## Conductor Bar in EMS-Systems Program 0811

## Contents

### 1 Collector Unit

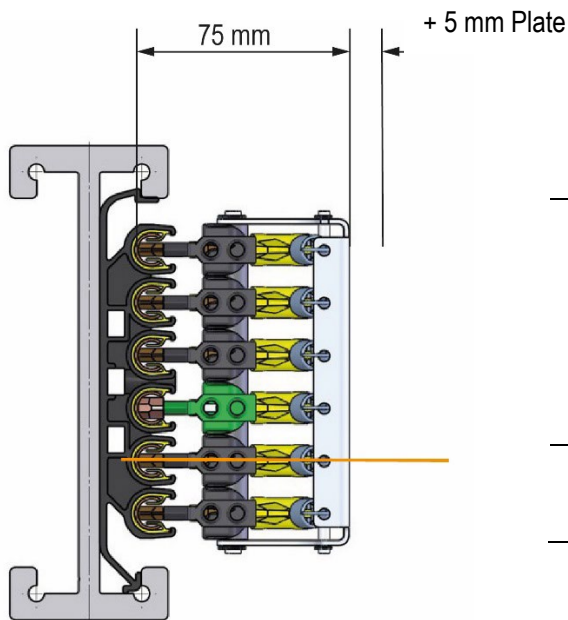
Fig. 4: Replace copper-graphite Collectors with pure graphite Collectors

1. Old copper- graphite collector height (when engaged): 80 mm (due to brush head with 10 mm height).  
New pure graphite collector height (when engaged): 75 mm (due to brush head with 5 mm height)  
Plate 5 mm must be used
2. Collector adjustment: Exact center line of copper rail and brush head to be kept

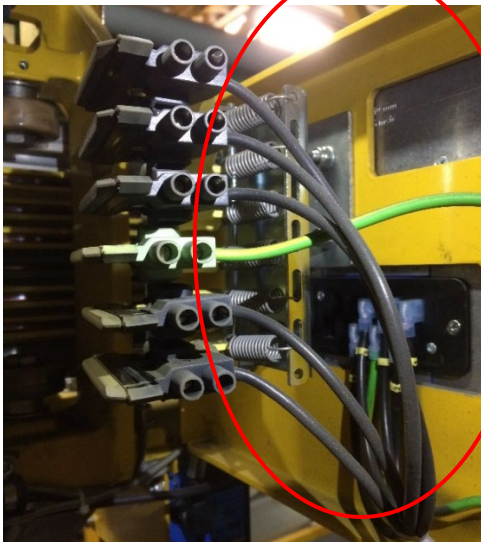
Fig. 5: Cables which are not installed correctly

1. Cables are not installed correctly:
  - No parallel cable guide
  - Cable bundle creates force on collector heads
  - Collector heads are not running parallel to conductor rail

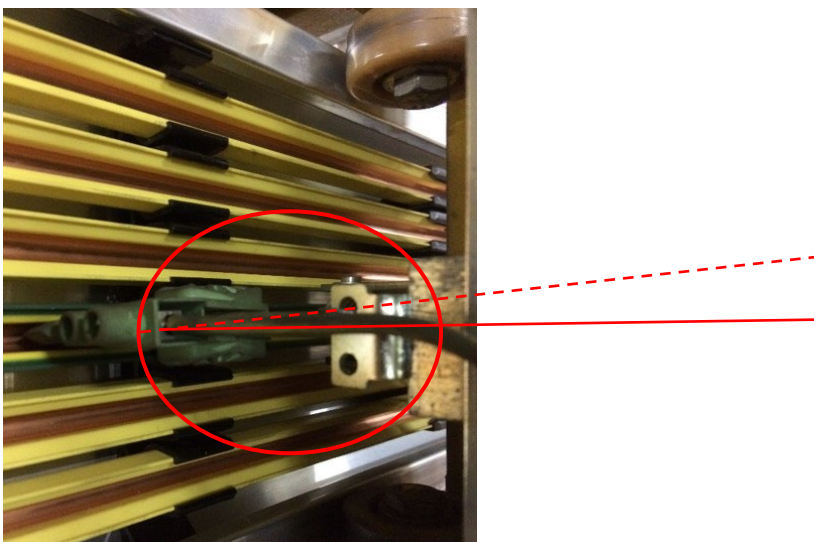
Fig. 6: Collector adjustment

2. Collector adjustment: Brush head not aligned properly (too high!) = Brush head runs permanently in an angle and grinds the plastic isolation of the conductor rail.
